## A Multi-Storey Car Park Fire – Was the Fire Strategy at Fault?

**Type of article:** case study

## The incident

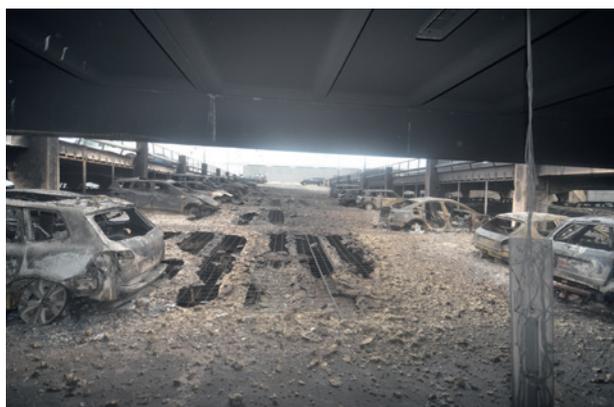
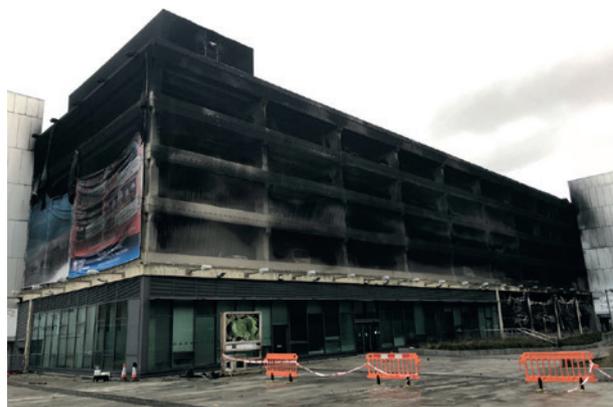
a)

b)

**Figure 2.** The aftermaths of the multi-storey car park fire in Liverpool: a) a view of the destroyed interior and cars b) a view from the street  
Source: Merseyside Fire & Rescue Service resources.

It is thought that an old Land Rover was the cause of the fire, when it burst into flames. This quickly spread from vehicle to vehicle until all the vehicles were on fire [4, 5]. Figures 1–2 show the fire and its aftermaths.
